DYNAMIC TESTS OF A PRESTRESSED CONCRETE MEDIAN BARRIER TYPE 50

SERIES XXVI

FINAL REPORT

CA-HY-MR-6588-1-73-06

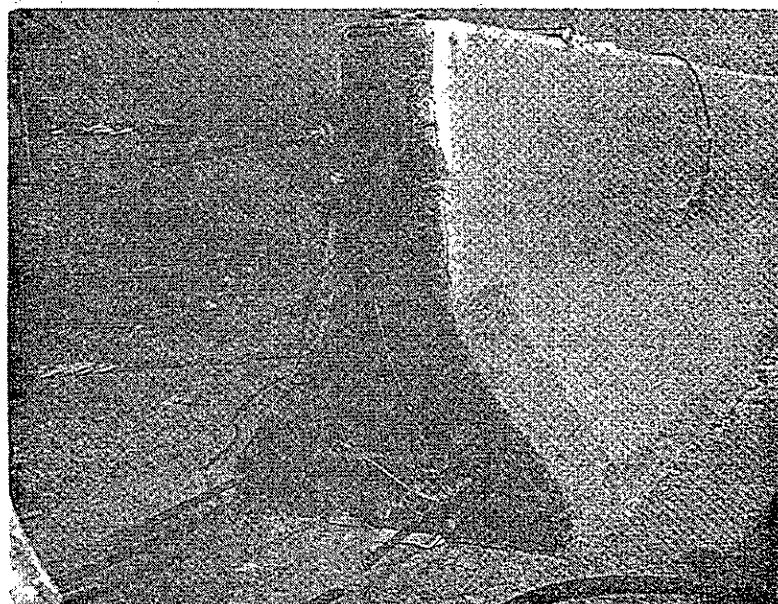
FIGURE 4, GAP BETWEEN BARRIER SECTIONS PRIOR TO PLACEMENT OF STEEL COVER PLATES. STRAND ANCHORAGE HARDWARE AND LOAD CELLS ARE IN PLACE.

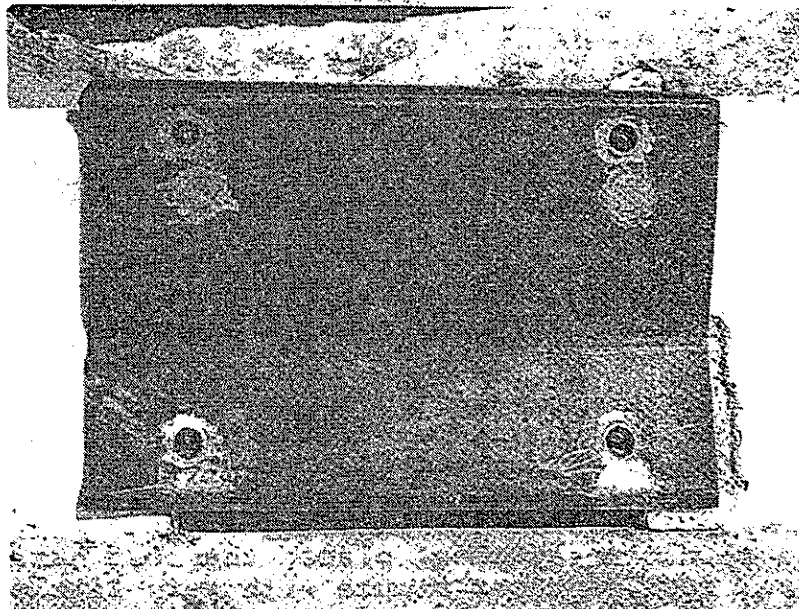
Following construction of the test barrier, a second barrier was installed in line with the test barrier leaving a three foot gap between the two barriers. This second barrier was identical to the test barrier except that it was placed on top of a cast-in-place footing. It was to be proof-tested in the case of failure of the test barrier, and, consequently, was never subjected to any impact tests. However, the three foot gap did provide for a prototype of the construction joint proposed by the developer. As shown in Figure 6, the gap was spanned by two steel plates which were bent to match the contour of the barrier. After the strands were prestressed, the steel plates were bolted in place but they did not provide any structural continuity through the joint.

FIGURE 6, STEEL COVER PLATES PROVIDE GEOMETRIC CONTINUITY THROUGH GAP BETWEEN BARRIER SECTIONS.

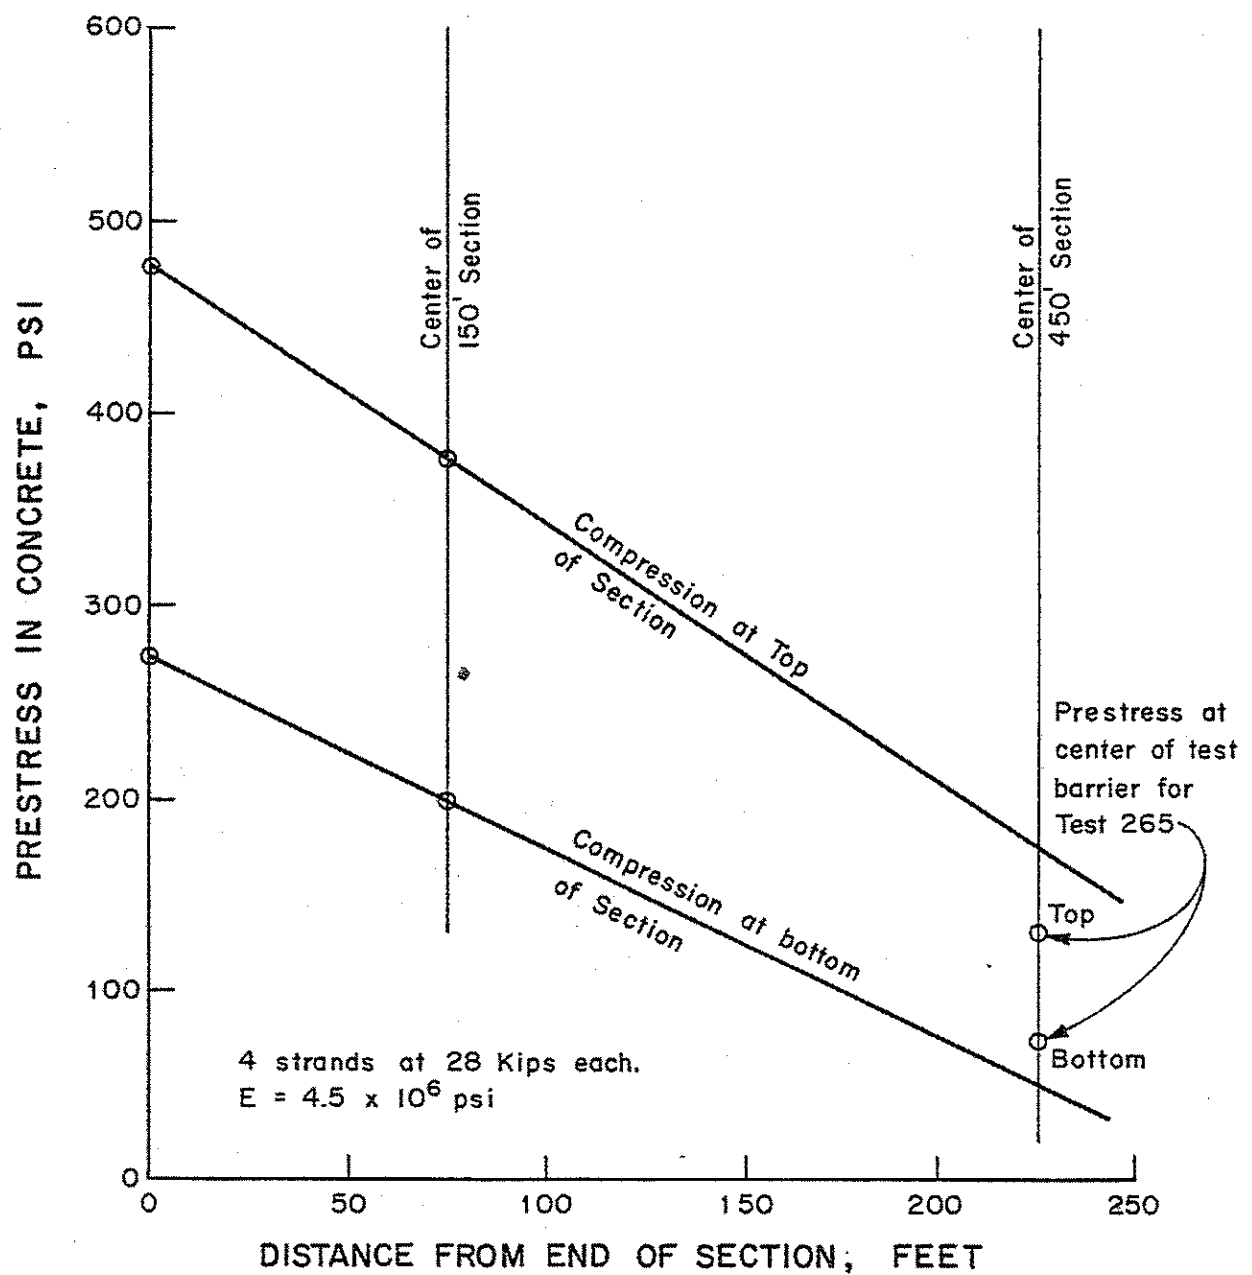
Although the tension in the strands was uniform throughout the length of the barrier, the prestress in the concrete varied significantly. The data obtained from a total of eight strain gages located on the surface of the concrete at the end and center of the 150-foot test barrier indicate that the effective prestress in the concrete is reduced as shown in Figure 8. This reduction in prestress in the concrete is due to friction and/or bond between the barrier and the pavement, and is, therefore, dependent upon many variables including type, condition, and thickness of pavement and length of barrier. The stresses shown in Figure 8 should, therefore, be considered only an estimate of stresses existing in actual installations. More exacting data could only be obtained by extensive testing. The description of instrumentation and details of obtaining this data are presented in the Appendix.

Based on Figure 8, the prestress conditions in the barrier for Test 265 were chosen to simulate the stress at the center of a 450-foot installation of prestressed barrier. Although the concrete stresses in any particular barrier are dependent upon the particular pavement conditions, the stresses existing at the center of the test barrier for Test 265 are considered reasonably conservative for a 450-foot barrier since they were relatively low -- about 130 psi at the top and 72 psi at the bottom of the barrier.

FIGURE 8, ESTIMATED LOSS OF PRESTRESS
 IN CONCRETE DUE TO FRICTION/BOND WITH PAVEMENT

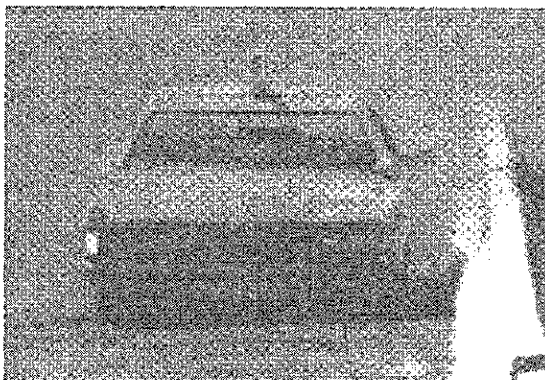
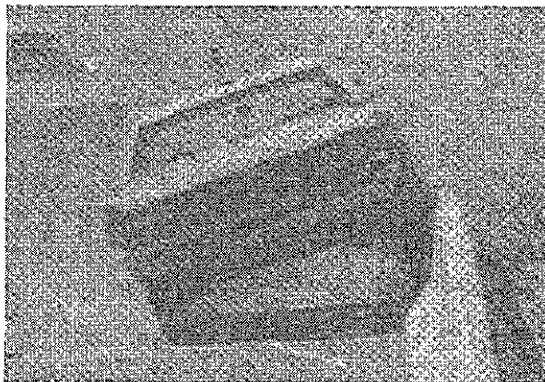
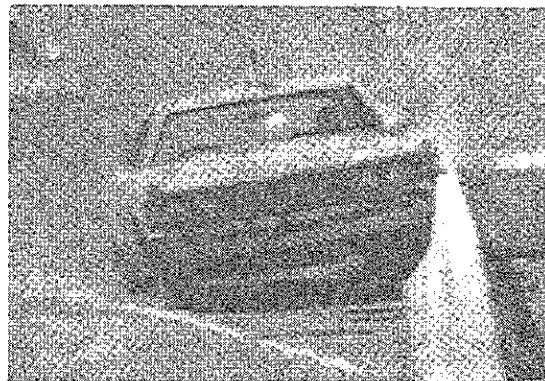
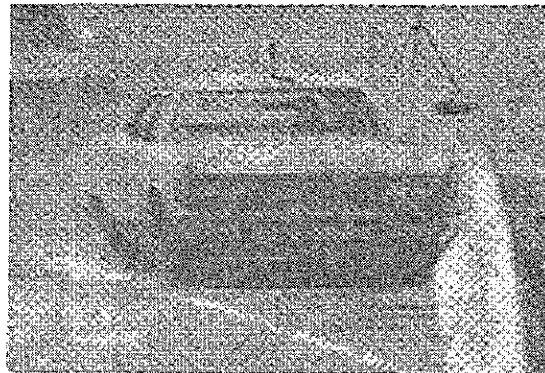
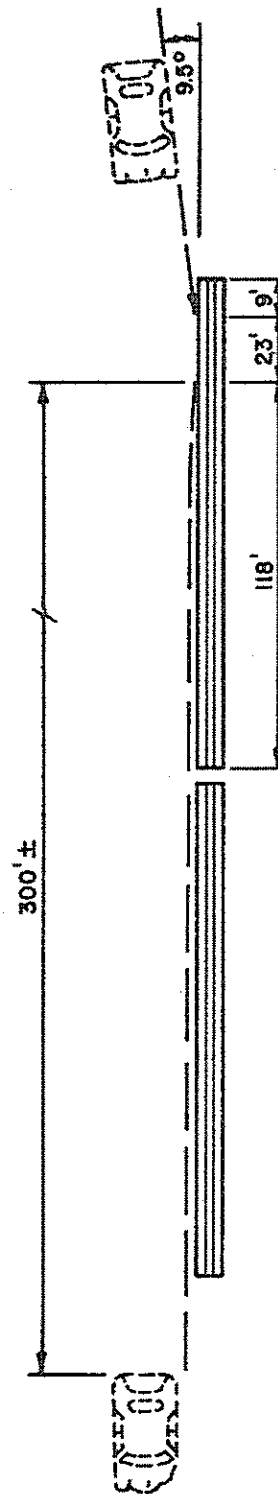
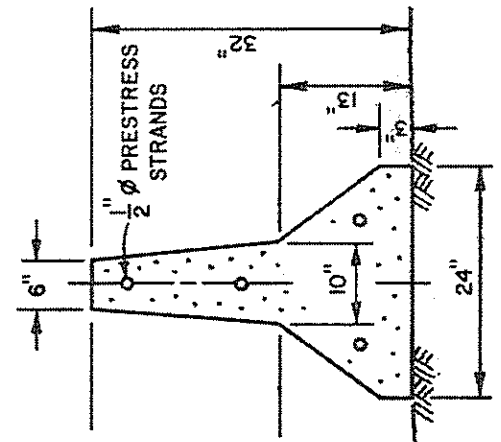
FIGURE 9, TEST 261

| VEHICLE DAMAGE..... | Minor | DUMMY RESTRAINT..... | lap belt |
| BARRIER DAMAGE..... | None | | |

A 1970 Mercury sedan traveling at 61 mph hit the barrier at an angle of 9.5 degrees from the barrier. The left front tire contacted the barrier at the same time as the left front fender, rode up to a height of 1.4 feet in the first 10 feet of contact, and remained at that height until it left the barrier 23 feet from the point of contact. Upon leaving the barrier, the car remained parallel to the barrier and within three feet of it for 300+ feet although no attempt was made to steer the car.

Vehicle damage was minor, consisting of slight deformation to the left fender and the left end of the front bumper and paint scratches along the length of the left side of the vehicle as shown in Figure 15. There was no mechanical damage to the

vehicle and it was used for a subsequent test the same day without any repairs. There was no barrier damage except for slight scratches and, of course, tire and body marks as shown in Figure 16.

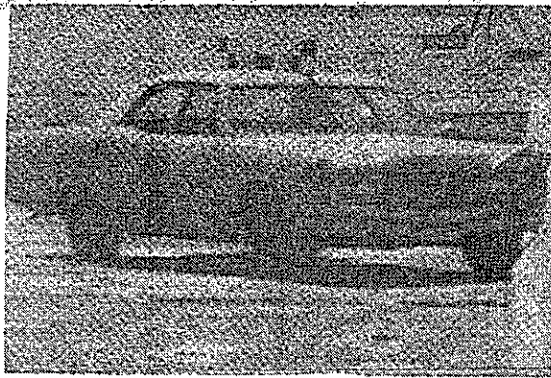
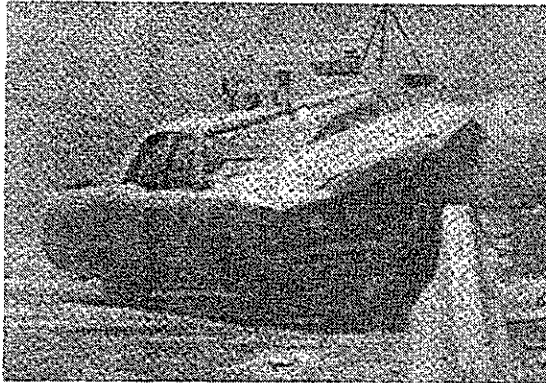
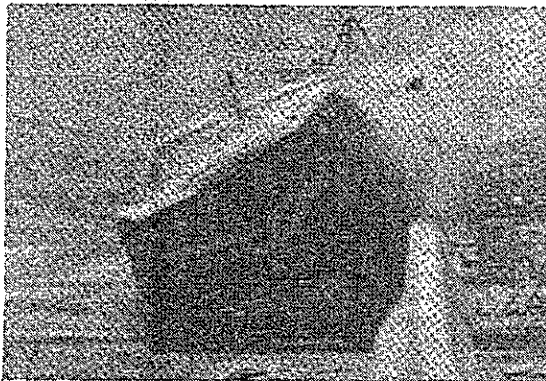
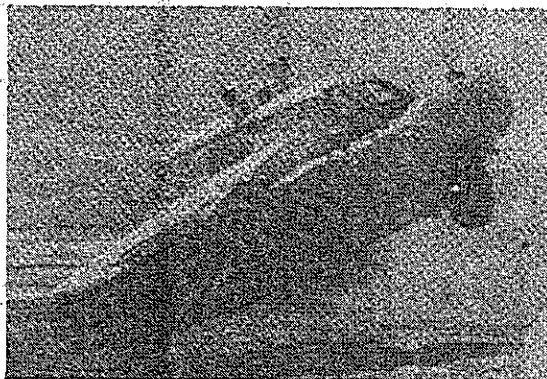
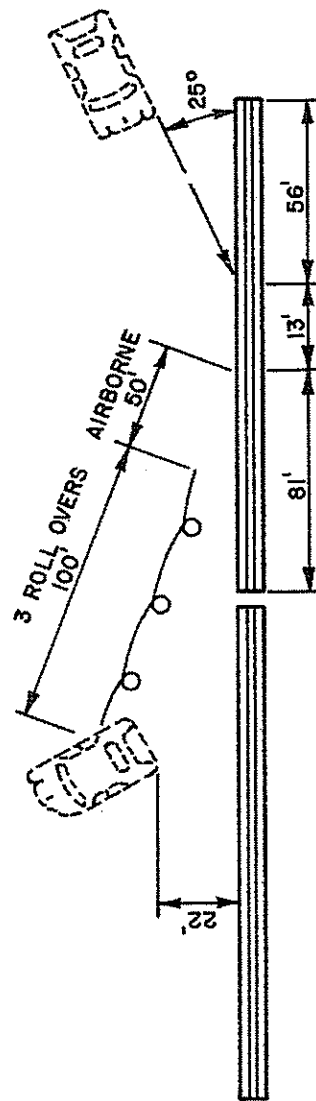
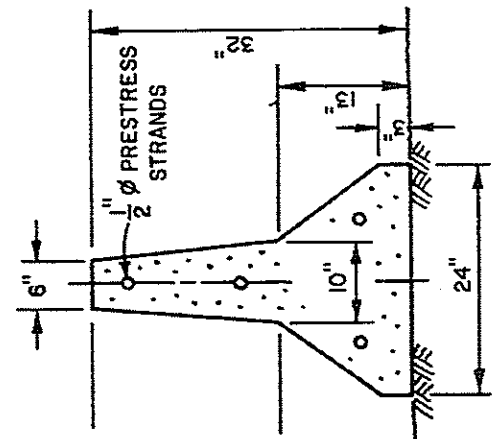
FIGURE 10, TEST 262

| VEHICLE DAMAGE..... | Total | DUMMY RESTRAINT..... | lap belt |
| BARRIER DAMAGE..... | None | | |

The same Mercury sedan that was used in Test 261 hit the barrier at an angle of 25 degrees and a speed of 59 mph. Immediately upon impact the left front quarterpanel and undercarriage were severely crushed. As the car was redirected, the left front fender rose about 3.1 feet with the car tilting about 25 degrees away from the barrier. After less than 13 feet of barrier contact, the car left the barrier nearly airborne and yawing to its right until it landed after traveling about 50 feet in the air. Upon

Although the car damage due to impacting the barrier was primarily confined to the left front end, the remainder of the car was totally destroyed by the three roll overs. As shown in Figure 18 the upper framework was severely distorted but the passenger compartment remained intact with the doors locked. Barrier damage was limited to minor scratches in the impact area and tire marks as shown in Figure 19.

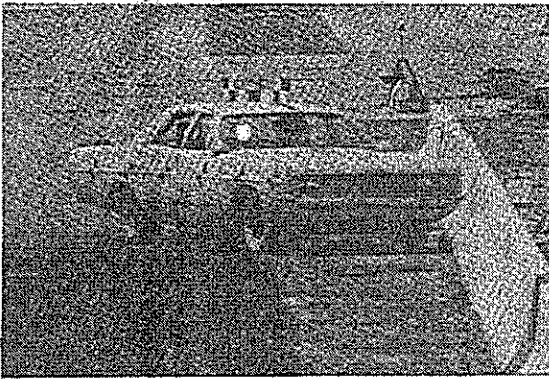
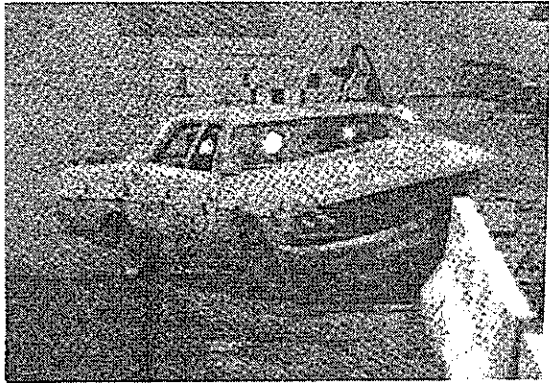
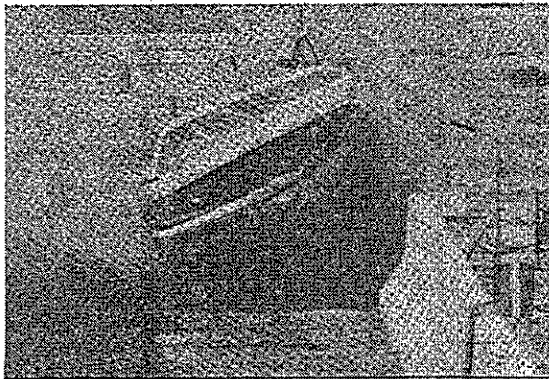
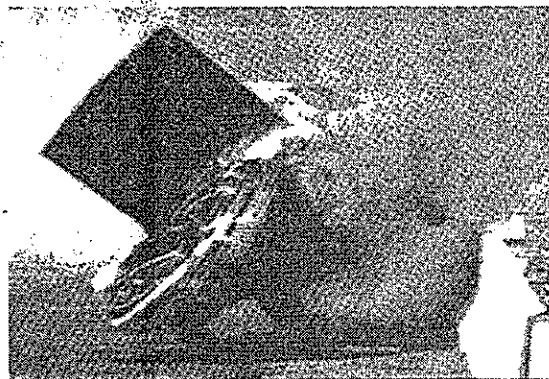
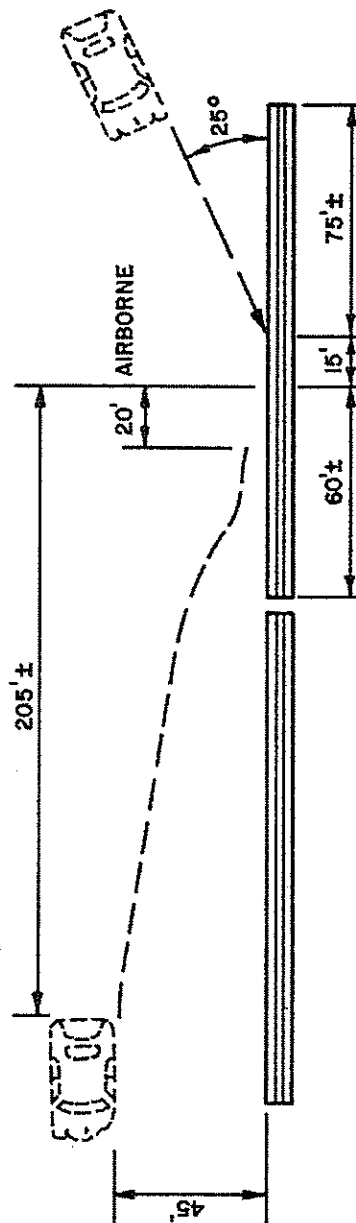
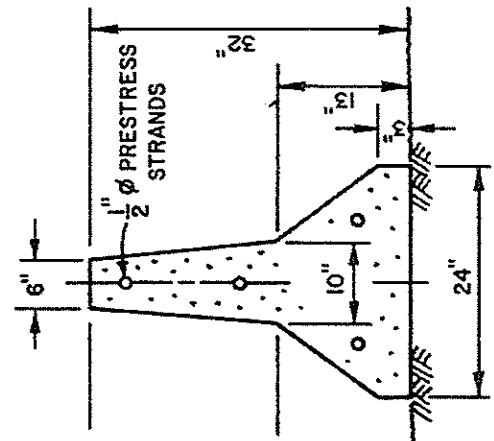
| VEHICLE DAMAGE..... | Severe Frontal | DUMMY RESTRAINT..... | lap belt |
| BARRIER DAMAGE..... | None | | |

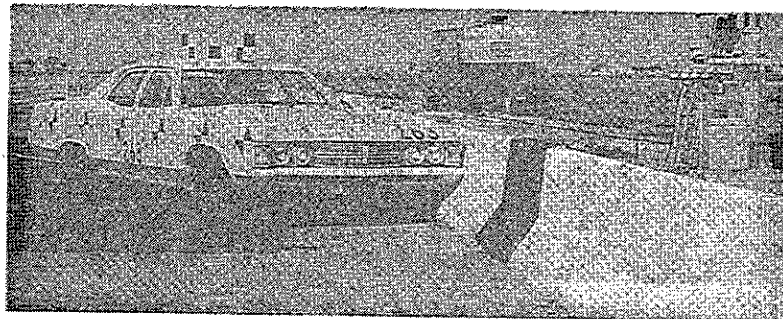
FIGURE 20, IMPACT NEAR JOINT TO PROOF TEST THE JOINT DESIGN.

A Mercury sedan, identical to one used in Tests 261 and 262, traveling at 66 mph and an angle of 25 degrees hit the barrier at a point 23 feet upstream of the joint. The vehicle motion and damage were virtually identical to those of Test 262. Although the dummy's movements were not filmed, inspection of the car's interior following the test indicated that the dummy's response was probably similar to that of Test 262.

Although the barrier successfully retained and redirected the car, it suffered what appeared to be a torsional fracture completely through the concrete section about 9 feet upstream of the impact point as shown in Figure 21. The prestressing strand did not allow the barrier to separate and restricted the movement of the free end to a lateral movement of about 5/16 inch at the top and no lateral movement at the base. Because this movement was small, the barrier was able to perform effectively, but its ability to sustain subsequent severe impacts was significantly reduced. Therefore, the construction plans presented in the Appendix require a reinforced cast-in-place joint in order to provide adequate structural continuity through the joint. The fracture plane was injected with epoxy prior to the next test in an attempt to restore the full continuity of the test barrier.
